FFD Rescue 29 Condition Report

12/10/2020

FF/Paramedic Eoin Bohnert, Maintenance Coordinator
Master EVT/ASE technician

FFD Engine 22 Condition Report

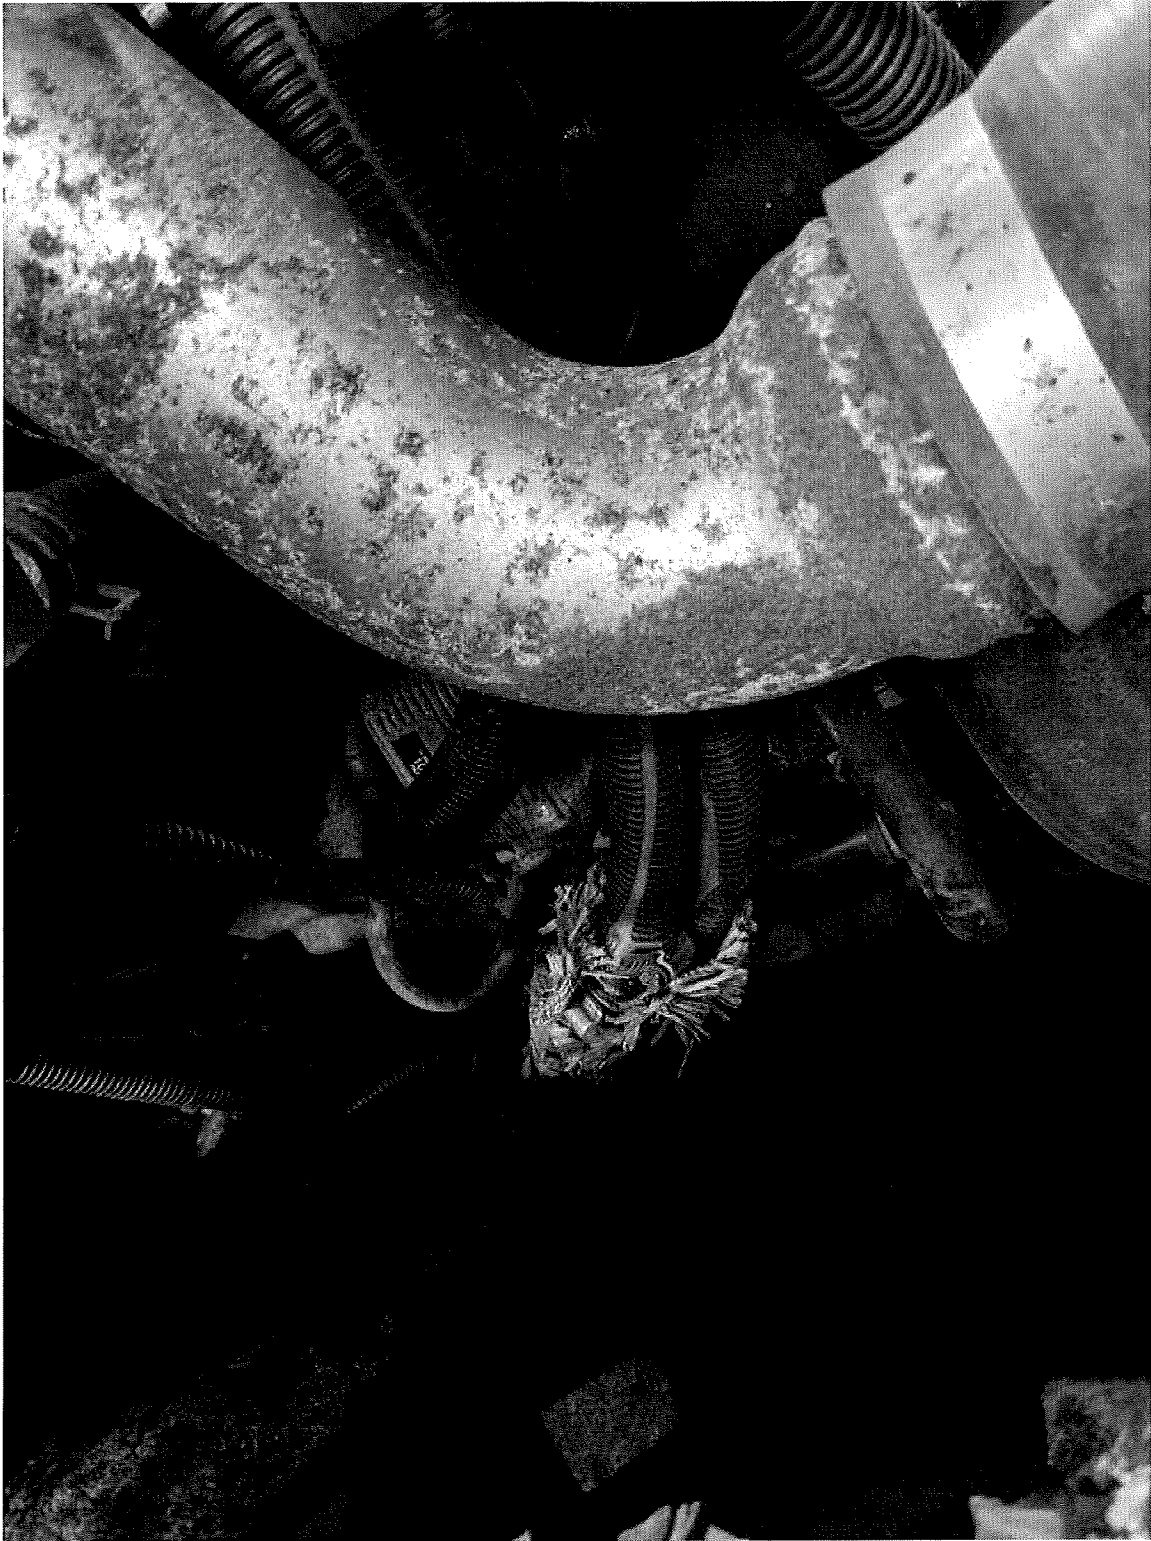
3. The rear ICC (upper marker) light circuit is inoperative, needs to be diagnosed.
4. There is significant corrosion on the engine charge air cooler tubes that will need to be replaced. (fig 2)

Figure 2- rotting air cooler line

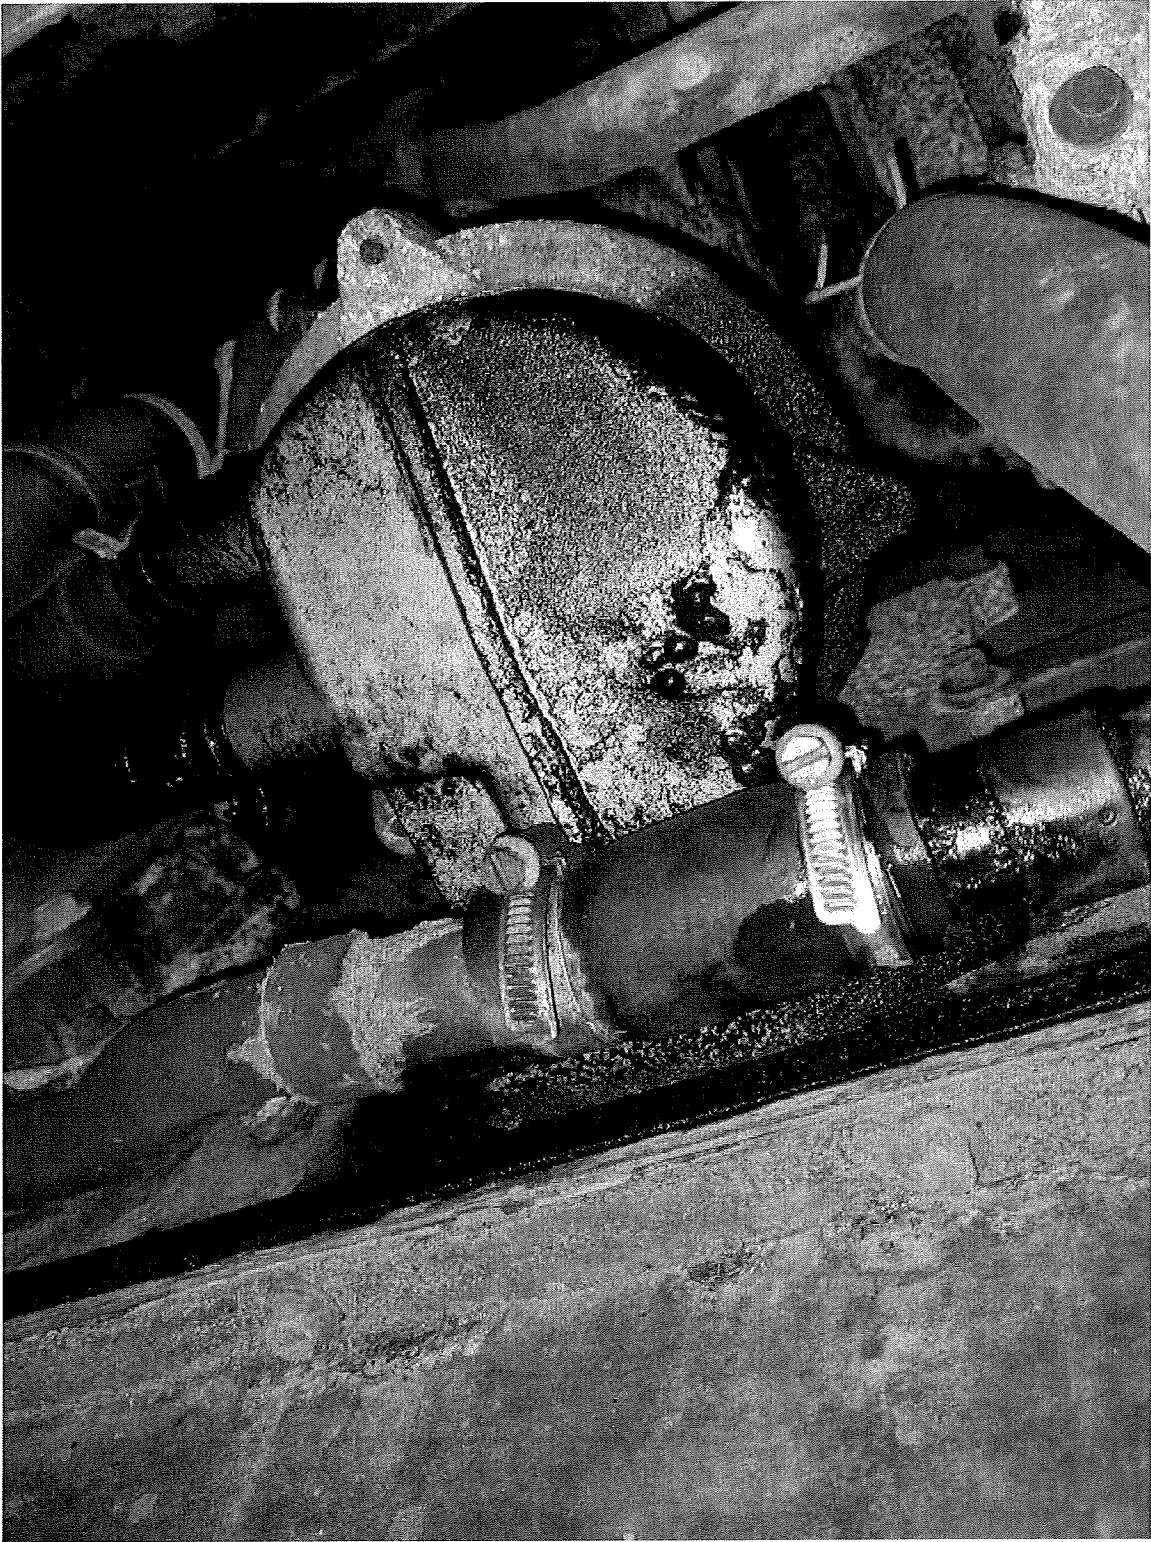
5. The vehicle has multiple oil leaks and also appears to be consuming oil outside of normal limits, indicating possible internal engine issue which will need to be further investigated. (fig 3)

Figure 3-oil leaks and rotting cooler line

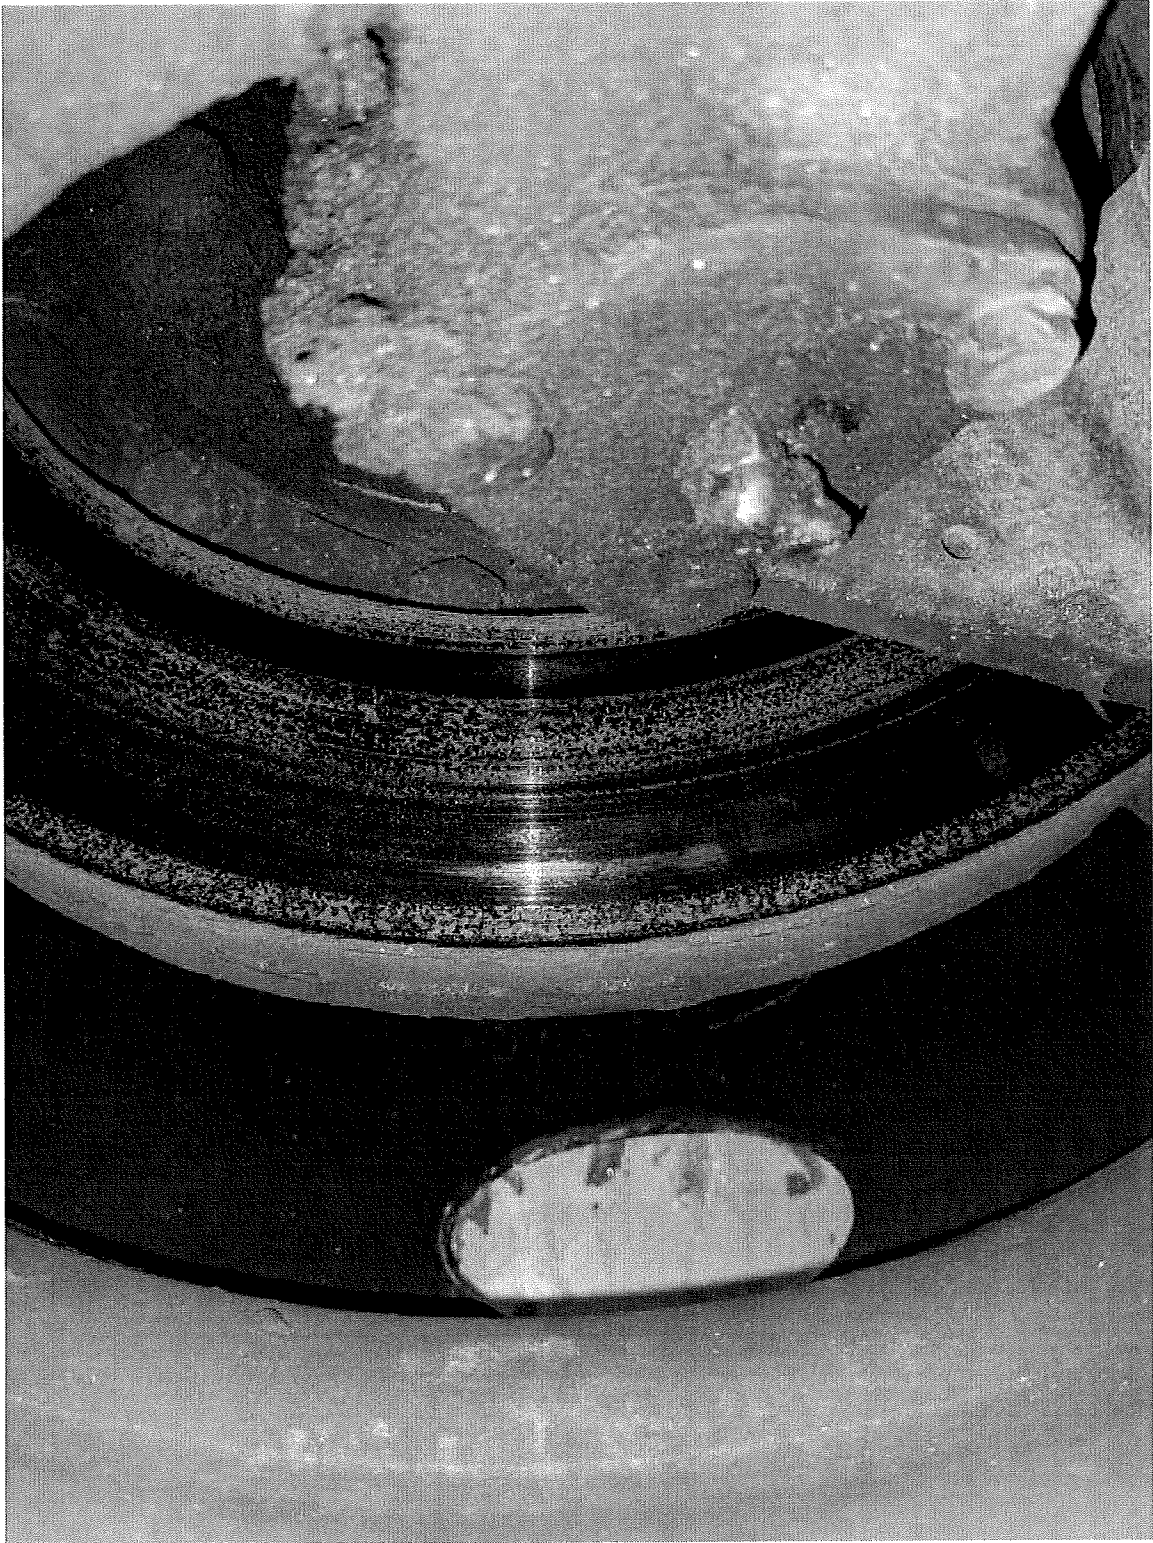
8. The vehicle needs front pads, rotors and calipers replaced. (fig. 4)
9. The drag link arm and tie rod ends have excessive play and need to be replaced. (fig. 5)

Figure 4- front rotors in need of replacement

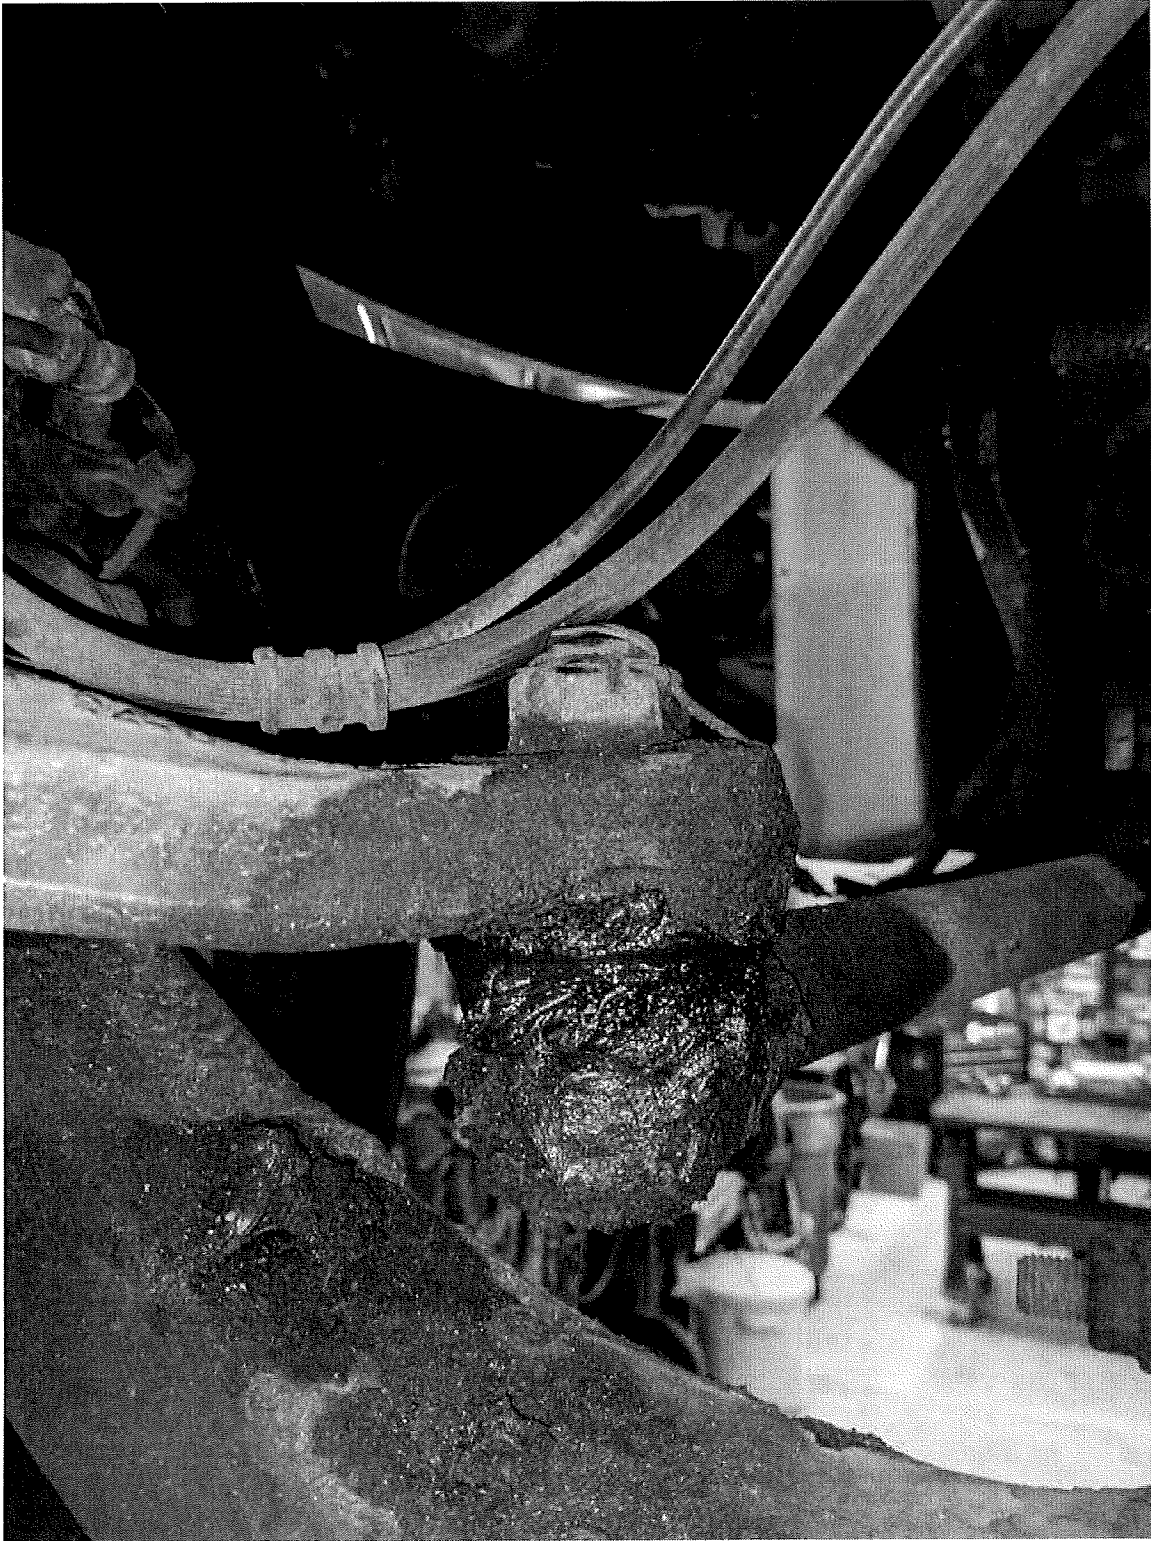
Figure 5- Drag link ends

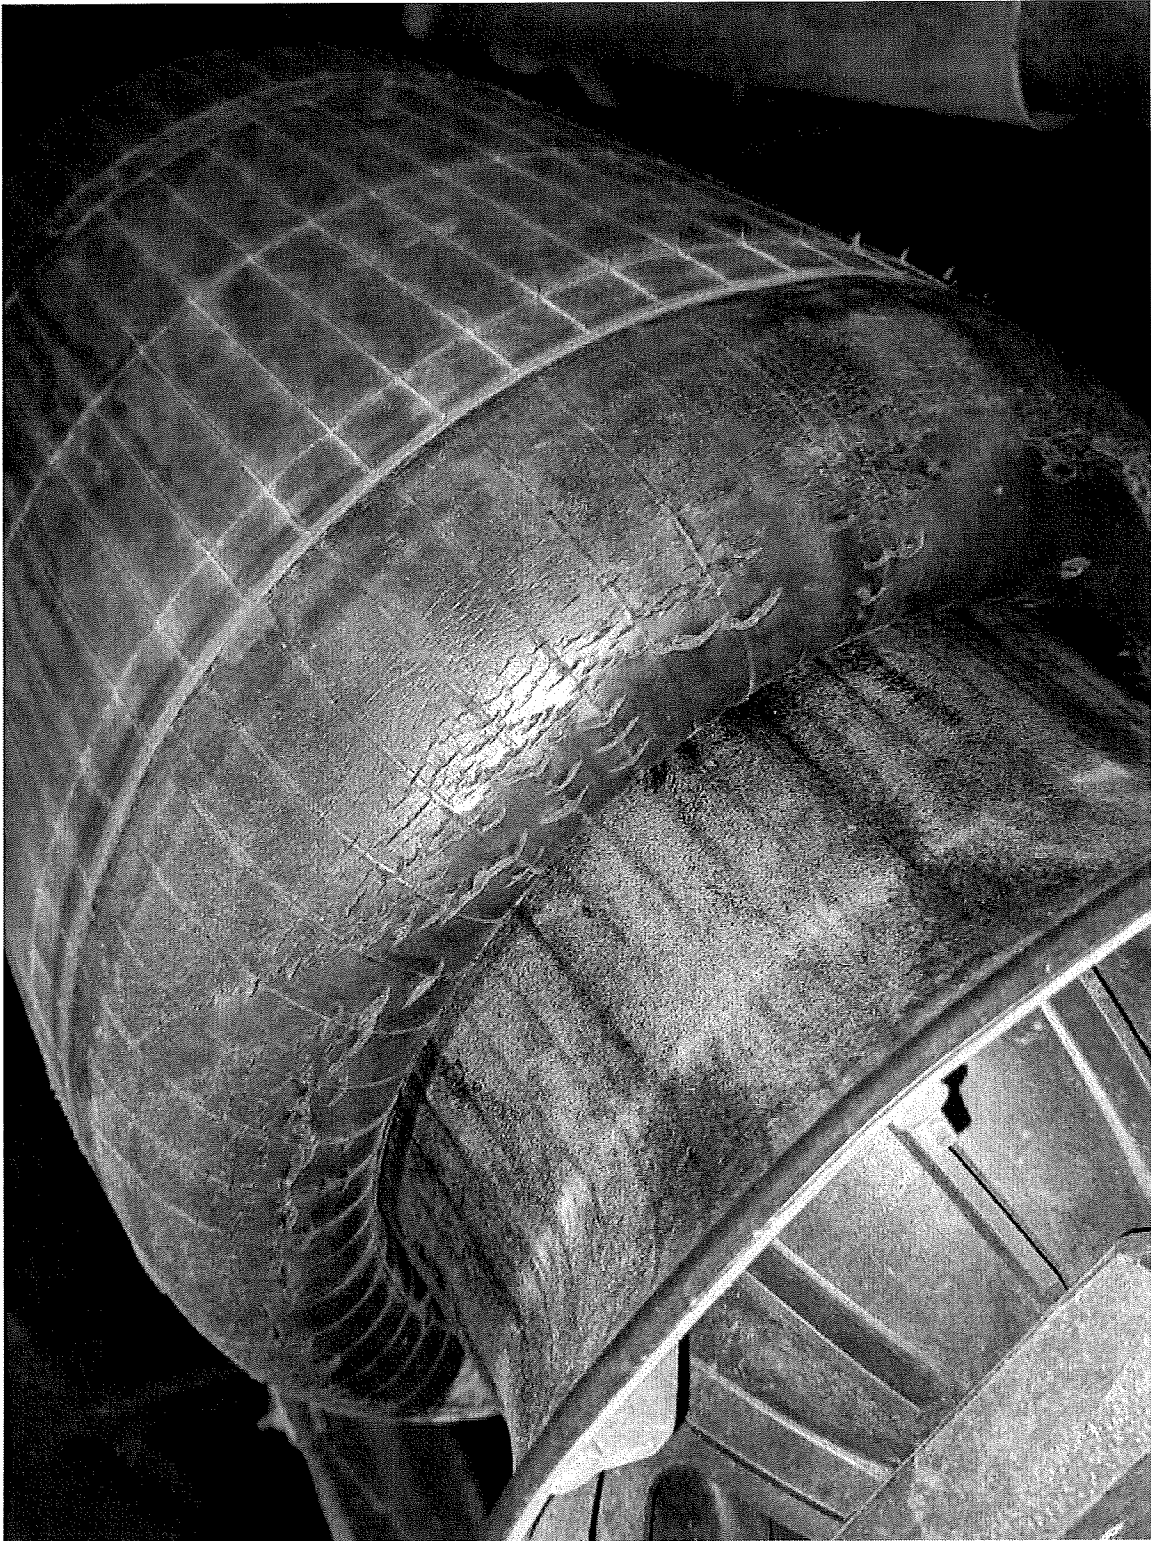
10. The rear air suspension bags have significant dry rot including two pin hole leaks and need to be replaced. (fig. 6)
11. The air suspension quick recovery or "ping" tanks both have significant amounts of rot and need to be replaced. (fig. 7)

Figure 6- rear air bags dry rotted and leaking

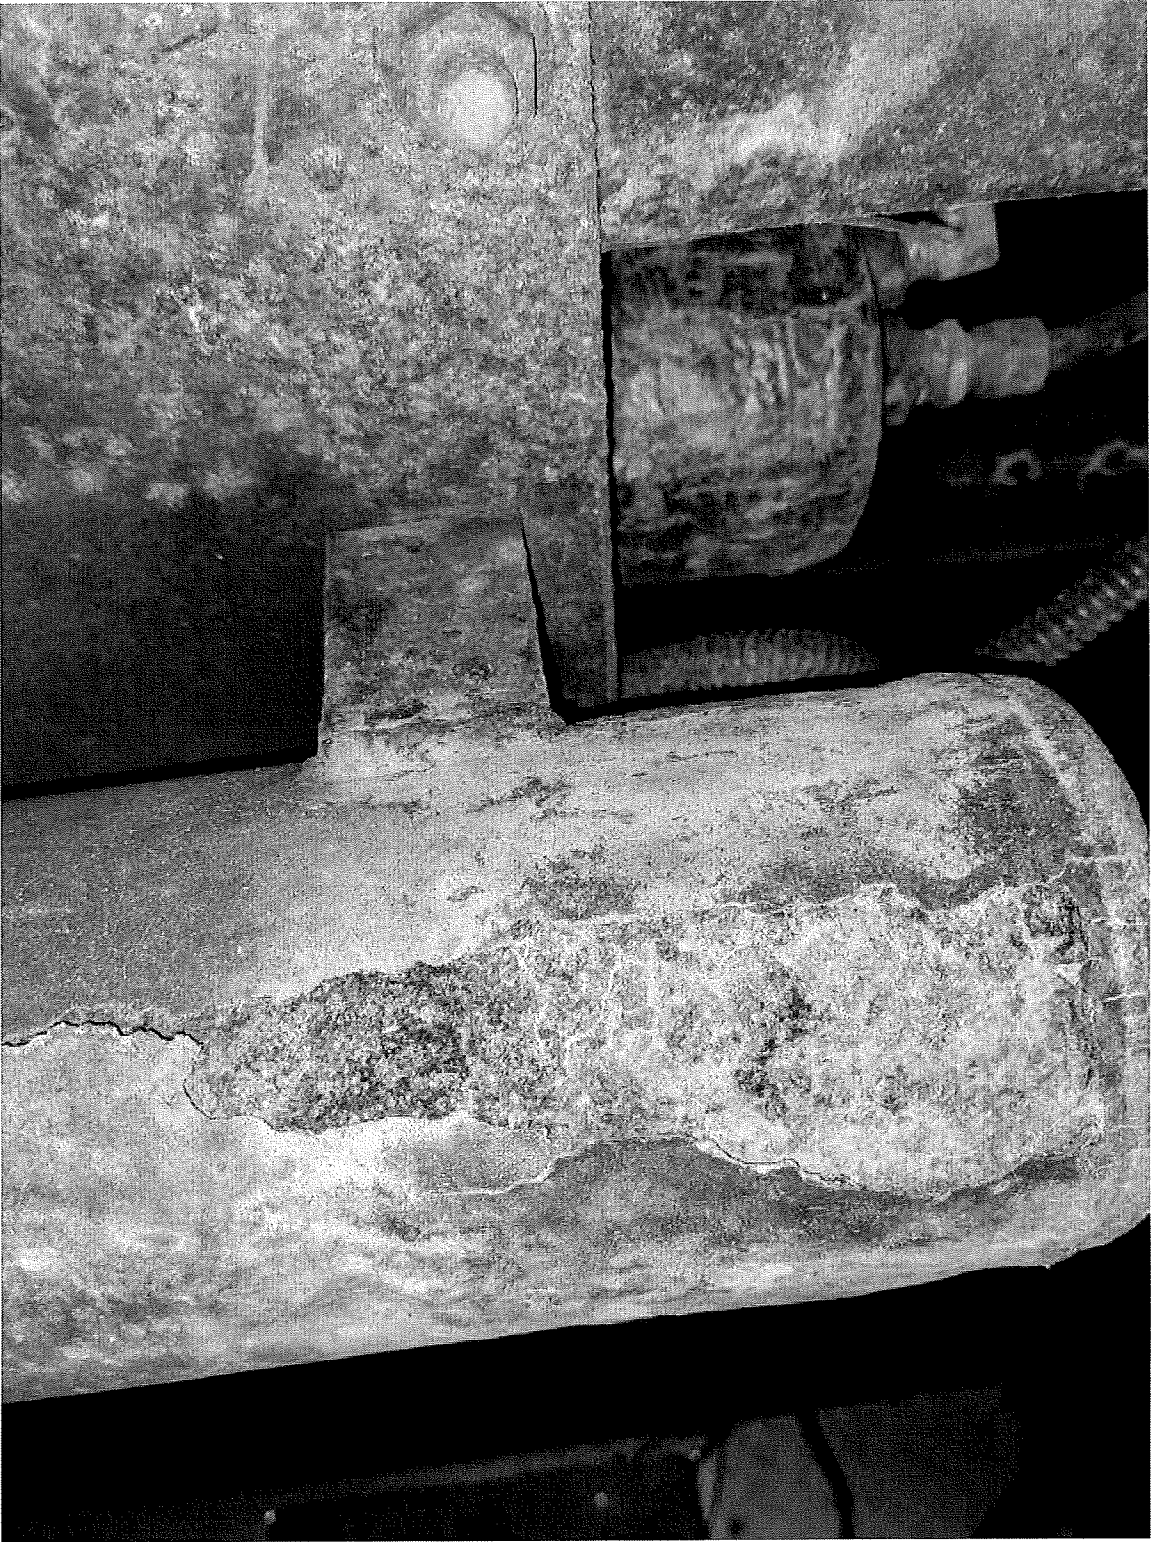
Figure 7- rotting quick recovery tanks

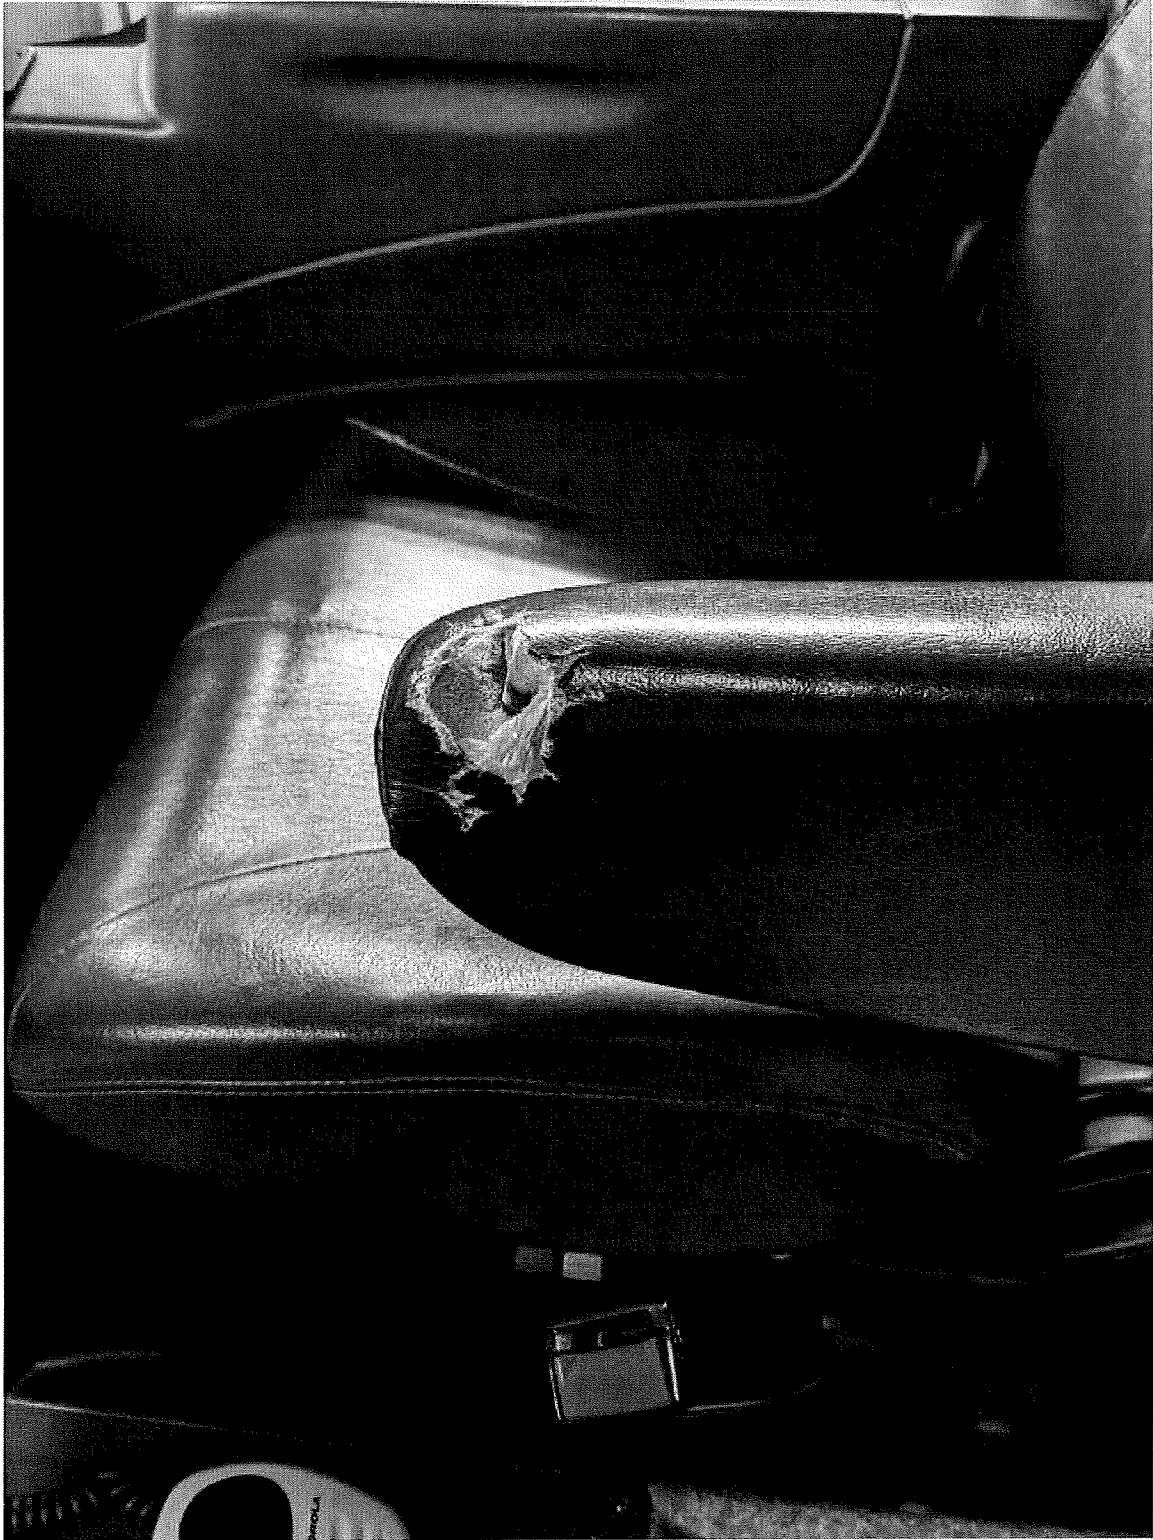
12. All vehicle batteries failed load test and need to be replaced.
13. Multiple instances of torn upholstery need to be replaced to prevent pathogen and fluid contamination.

Figure 8- one of many instances of torn upholstery in cab and patient compartment areas
