MEMORANDUM

RE: **Riverfront Area Regulatory Review**
119 Morse Street
Foxborough, Massachusetts
Pare Project No.: 18170.29

RIVERFRONT AREA REVIEW MEMO

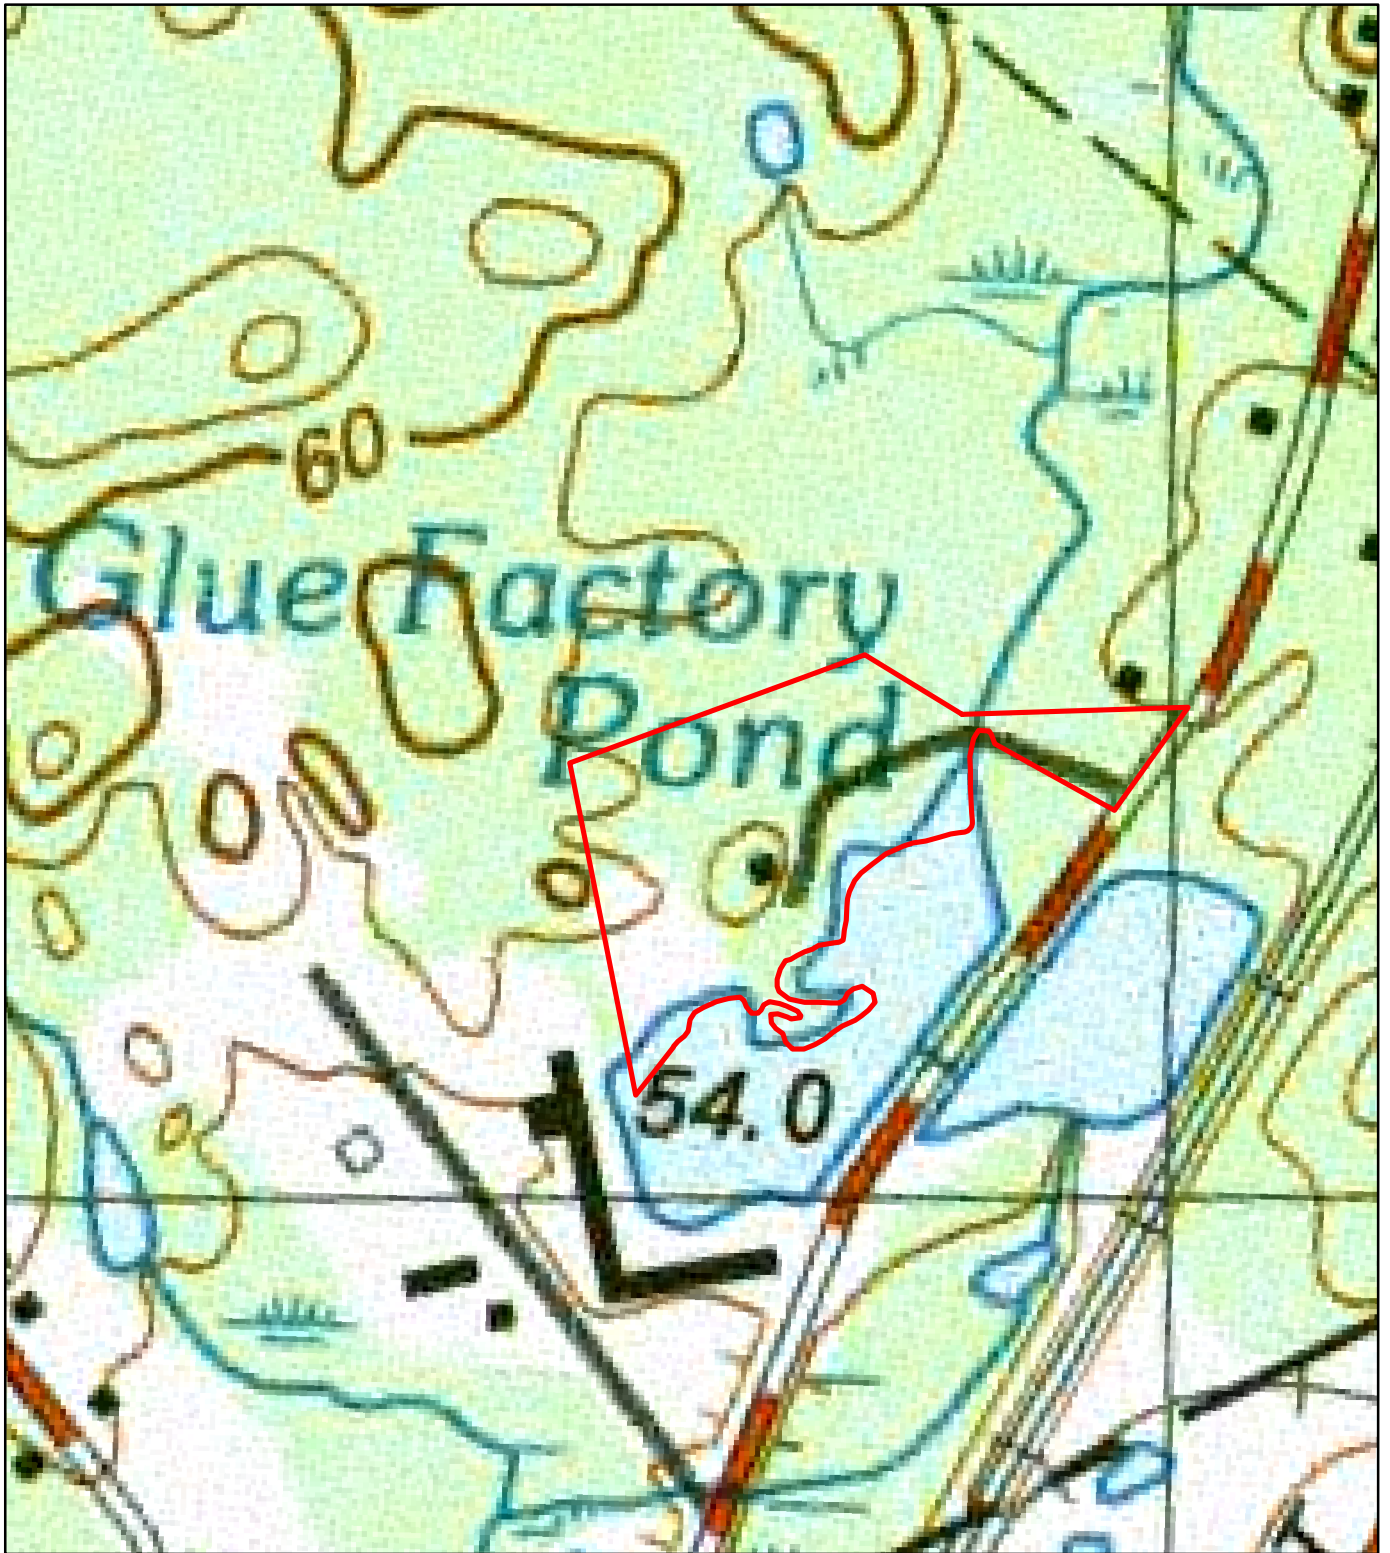
FIGURE 1

The USGS Topographic Quadrangle (Figure 1) shows the Rumford River as a thick blue line (perennial river) which ends just south of the driveway crossing at the inlet to Glue Factory Pond, which is clearly mapped as a pond.

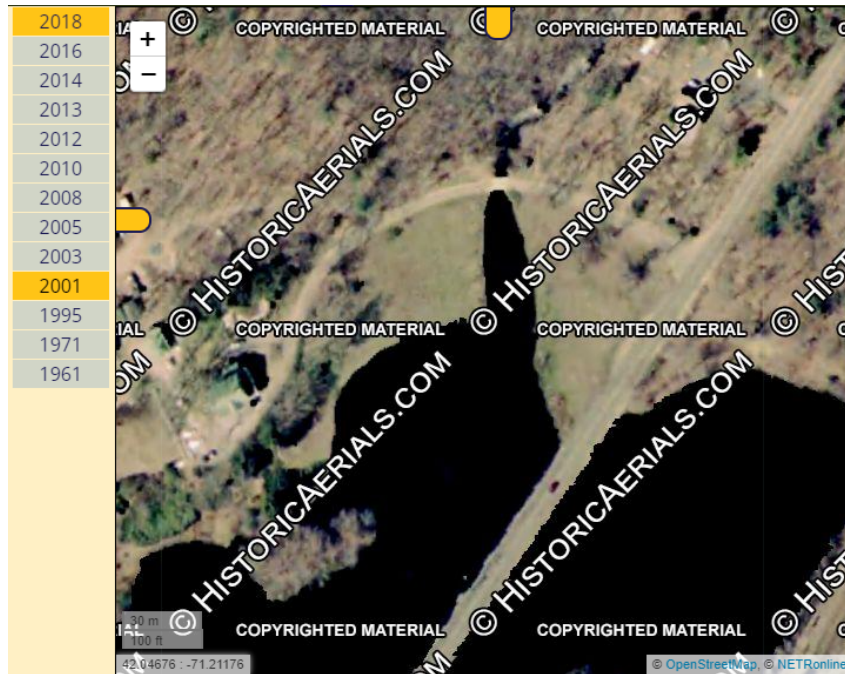
Exhibit 1: 2001 Aerial Photograph

Pare did not observe riverine characteristics downstream of the driveway bridge during either delineation date in 2021. Upstream of the driveway, the river consists of a rocky channel approximately 20 to 25 feet in width with clear visual observation of flow. The river passes under the bridge which consists of an approximately 20' wide span.. Downstream of the driveway there is a distinct and abrupt change in character from a rocky 20-25' wide channel with readily observable unidirectional flow, to a cove of standing water 40-60 feet wide at the northeast side of the pond. These observations are consistent with Pare's previous determination, which was verified in an ORAD in 2007. Review of aerial photographs (Attachment B) indicates that the area appears to remain unchanged between the time prior to the former ORAD and the present.

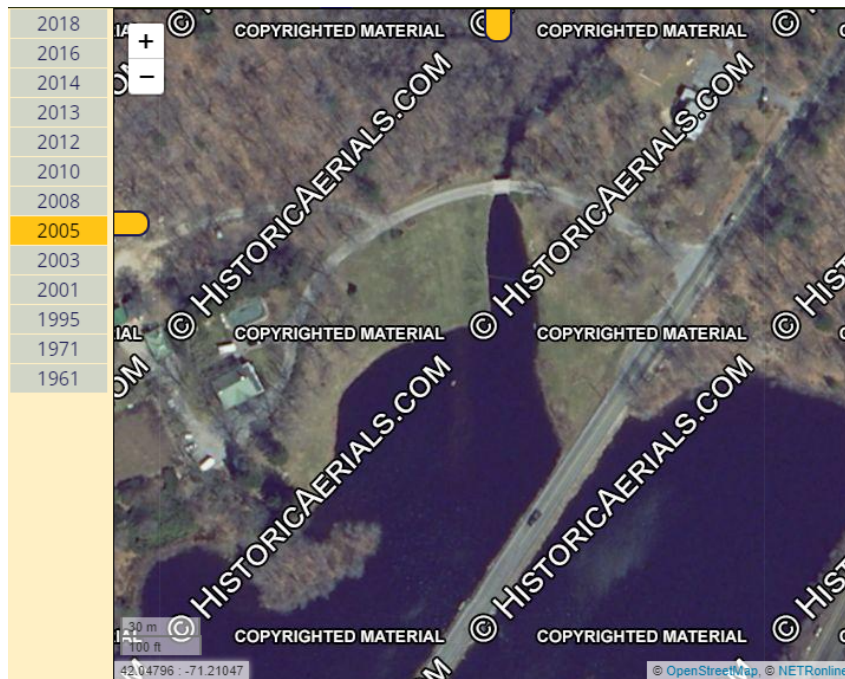
Exhibit 2: 2005 Aerial Photograph (most recent prior to 2007 ANRAD)

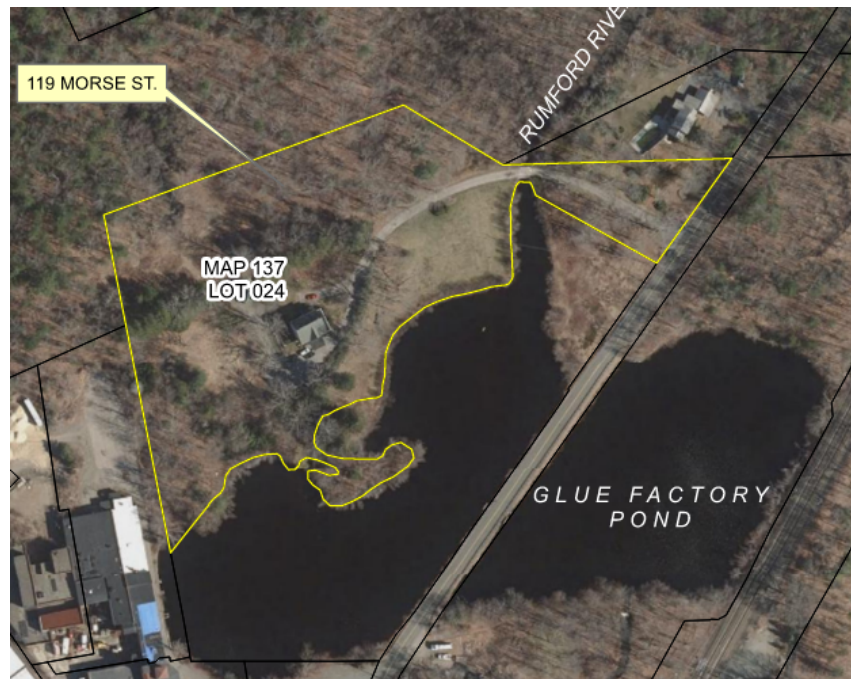
Exhibit 4: 2019 Aerial Photograph (most current)
